## **Upgrading and Reconstruction of a Collapsed Man-Made Lake Embankment Founded on Salty Soil**

**A. A. Abdel-Motaleb, A. A. El-Ashaal and S. Elkholy**

*Construction Res. Institute, National Water Res. Center, Egypt*

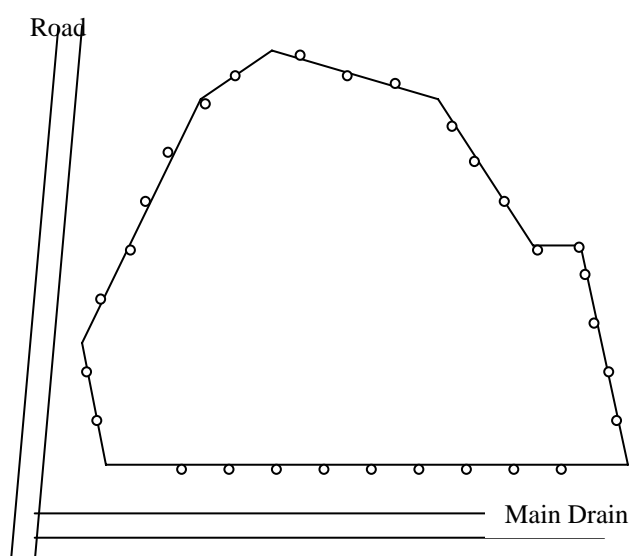
Examining the failed embankment showed the presence of an intercepting drain at the downstream toe of the embankment. Improperly designed toe drain can cause trouble for embankments (Dewey, 1993). It was noticed that internal erosion started at the toe drain and could have been one of the factors that lead to the failure. It was also found that the embankment site was originally a salt bed and that the embankment was constructed directly on the ground without any treatment. The geotechnical field study consisted of 29 boreholes along the lake embankment. The spacing between the boreholes was about 120 m. The depth of the boreholes ranged between 14.25 m and 20.0 m. Standard Penetration tests were done in the sandy soil layers. Another 29 locations were bored for the Static Cone Penetration tests along the lake embankment. The readings were taken every 0.5 m down to a depth of 10 m for each hole. Undisturbed and disturbed samples were extracted from the boreholes. Figure 1 shows a sketch of the locations of the boreholes along the lake embankment.

Figure 1. Sketch of the drainage lake embankment and the locations of the boreholes along it.

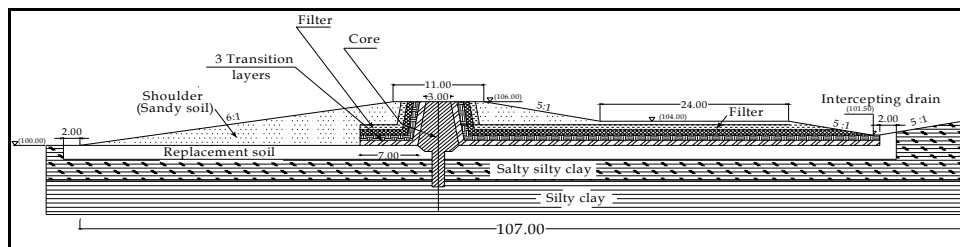
The suggested cross section of the embankment is shown in Figure 2. The height of the embankment is 6.0 m and the maximum depth of water in the drainage lake is 5.0 m. The total depth of the salty layer at the surface must be completely replaced with the silty sandy clay soil, with a minimum depth of 2.0 m. The impermeable core has a width of 3.0 m at the top and 5.0 at the bottom. To minimize the amount of water seeping through the embankment, the core is extended down through a trench to penetrate the silty clay layer for a depth of at least 1.0 m and a width of 1.5 m. A filter and three transitional layers, each is 75 cm thick, protects the core at the upstream and downstream sides. The first layer near the core is a mix of 80% of the core soil with a 20% of the filter soil. The second layer is a mix of 30% of the core soil with a 70% of the filter soil. The third layer is a mix of 10% of the core soil with a 90% of the filter soil. Then follows the shoulders, 15 cm thick filter of sand and gravel, and a 30 cm thick external protection layer of gravel.

Figure 2. Details of the suggested cross section of the new embankment.

Since improperly designed toe drain can cause trouble for embankments (Dewey, 1993), an intercepting open drain, to relieve pore water pressure and collect any seeping water, is made at a distance of about 45 m downstream the embankment to avoid any piping that would lead to internal erosion at the downstream toe of the embankment. The filter around the core is extended for 7.0 m upstream the embankment and until the intercepting drain downstream the embankment.

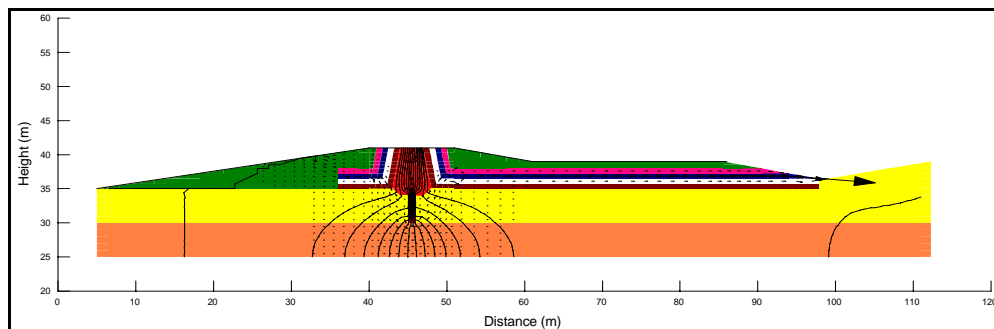
The seepage analysis was used to estimate the amount of water seeping through and underneath the core of the embankment and collected in the intercepting drain. The amount of seeping water in the intercepting drain was estimated at about  $1.2 \text{ m}^3/\text{day}/\text{m}$ . This amount is considerably small and could be collected and pumped into the drainage lake. Figure 4 shows the flow lines and equipotential lines in the case of maximum water level in the drainage lake

Figure 4. Flow and equipotential lines through and underneath the embankment.

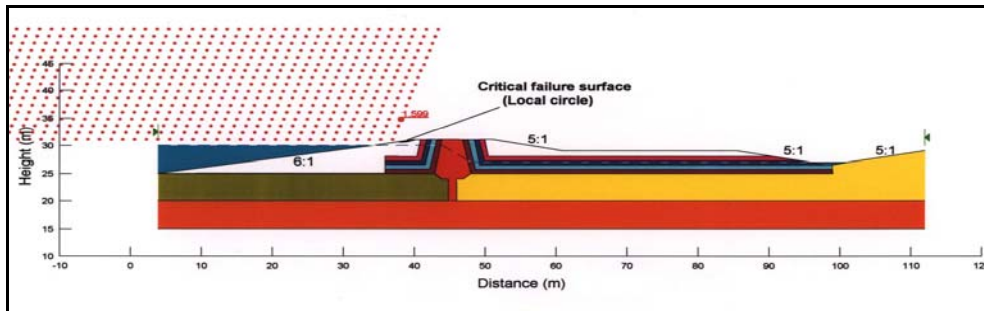
be 6 (horizontal) : 1 (vertical) and 5 (horizontal) : 1 (vertical) for the downstream slope. It was noticed that the critical circles are local circles. The minimum factor of safety for the upstream slope is 1.6 and for the downstream slope is 1.82. Figures 5, 6 show the critical circles and their factor of safety in the upstream and downstream sides consequently.

Figure 5. Critical circle and its factor of safety of the upstream slope.

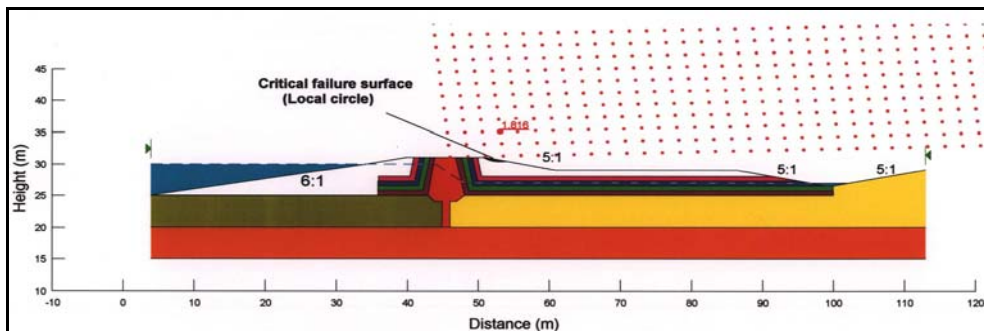
Figure 6. Critical circle and its factor of safety of the downstream slope.

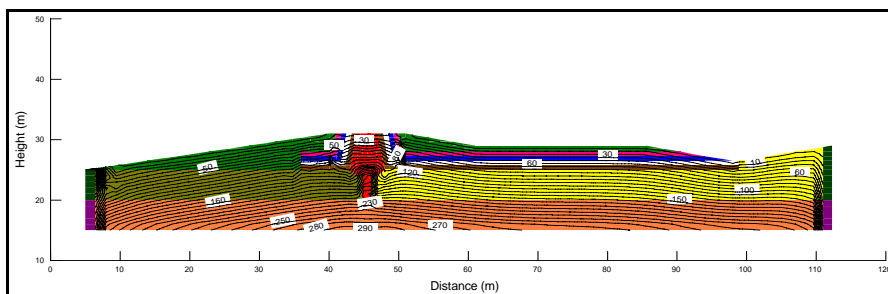
Figure 7. Contour lines of the total vertical stresses in the embankment.

Figure 7 shows the contour lines of the total vertical stresses in the embankment and underneath it. It shows that the maximum total vertical stress in the embankment is at the contact plane between the bottom of the impermeable core and the replacement layer, that is at a depth of about 1.5 m below the original ground surface, with a value that range between 11 kN/m<sup>2</sup> and 18 kN/m<sup>2</sup>. The total vertical stress reaches 23 kN/m<sup>2</sup> at the bottom of the cutoff trench, that is at a depth of about 6.5 m below the original ground surface. Then, the total vertical stress keeps increasing with the depth until it reaches the value of 29.5 kN/m<sup>2</sup> at a depth of about 11.5 m below the centerline of the embankment, that is the bottom of the model. These values are all less than the maximum strength of the soil.

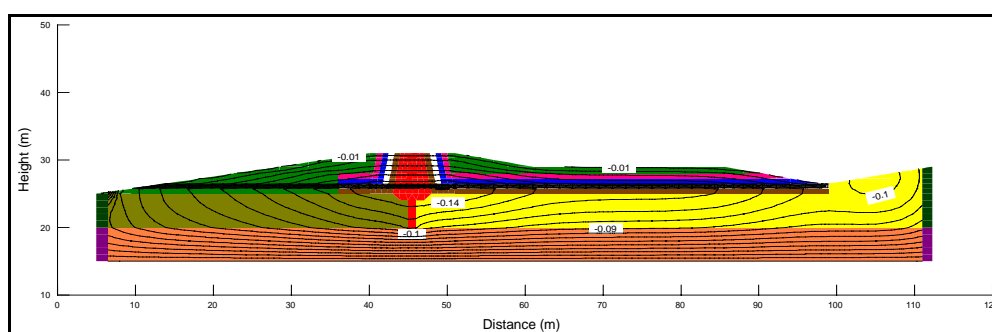
Figure 8. Contour lines of the vertical displacements in the embankment.

Figure 8 shows the contour lines of the vertical displacements in the embankment and underneath it. It shows that the maximum accumulative vertical displacement is 14 cm below the core near the downstream side. The value of the vertical displacement decreases with either going up or down from the bottom of the core until it reaches 1 cm at the top of the embankment and at the bottom of the model.
