Cause and Combat of Agriculture Land Desertification in Egypt Related to River Processes

Karima Attia and Yasser Raslan

Head of River Management and Modelling Department,
Deputy Director Nile Research Institute, Cairo, Egypt

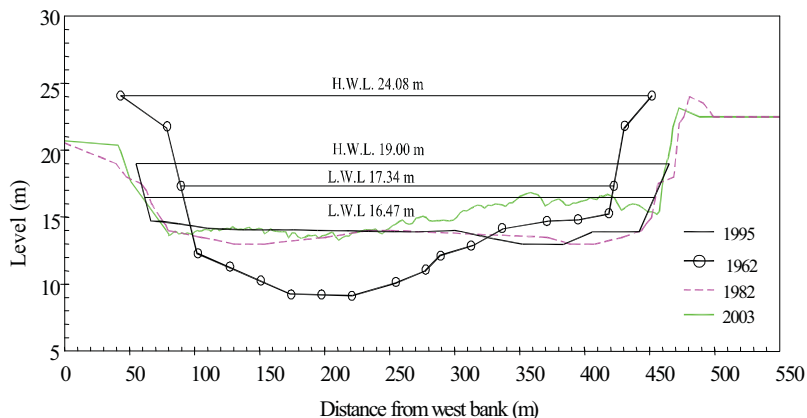
Fig. 2: land erosion as a result of river processes after the construction of AHD at Ekhsas location

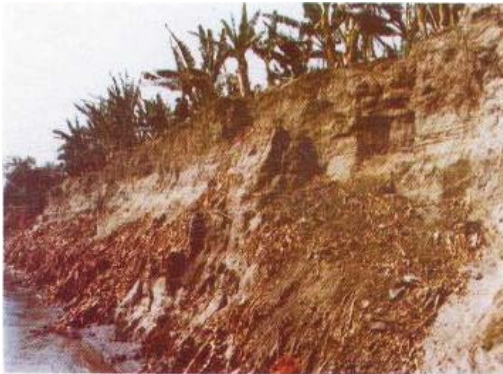
Photo 1: Composite land failure as a result of toe material removes (hydraulic factors)

The main forces that erode soil material were hydraulic forces (see photo 1 and Figure 3), geotechnical instabilities and a combination of both. The flow adjacent to the agriculture land exerts a stress that exceeds the critical shear stress for soil erosion and therefore the movement of the particles is initiated. Fluctuation of river water resulted in pore water pressure increase in the soil mass during the falling time and this increases

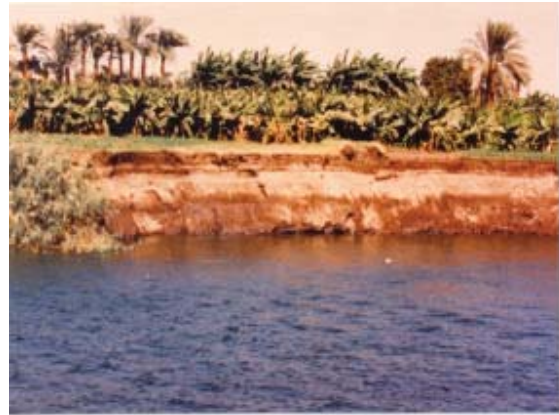
Photo 2: land erosion due to seepage effect

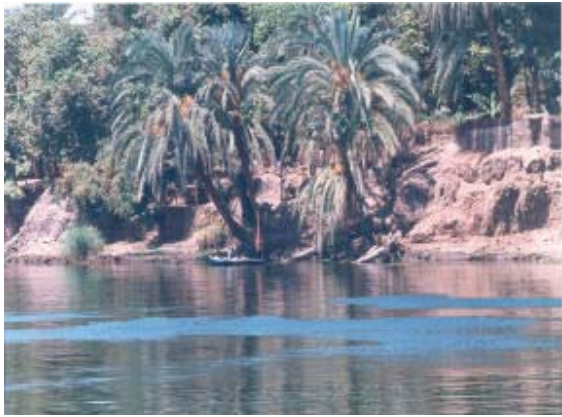
Photo 3: Steady progressive soil erosion reveals the root of palms

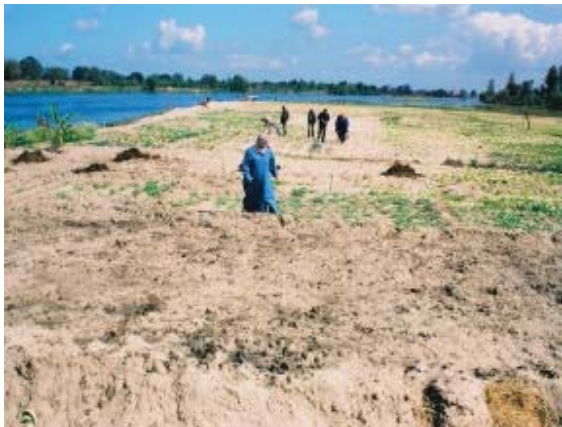
Photo 4: Low land heightened by dredged material in Damietta branch

Rehabilitation work was undertaken in river Nile by the River Transport Authority (RTA) since 1999 to enhance river transportation. This involved the dredging of bed materials to satisfy water depth of 2.3 m from places where deepening is required. The dredged materials are reused

by farmers to heighten their agriculture land to avoid inundation during high stage of the river. The farmers are unaware that these materials may have great potential of contaminants. Their concern is only concentrated that these materials will enable them to cultivate their land the entire year. Samples of dredged material (photo 4) are collected from 10 locations along Damietta branch, March 2008 to assess the extent of heavy metals in the soil due to dredged materials. The analysis indicates that soil type is sand which means light texture with high permeability. The PH values for the row dredged materials vary from 7.53 and 8.58 which indicate that the soil is neutral with the tendency of alkaline in one location. This problem can be combated by using organic fertilizer to produce CO₂ to decrease the PH value to the range 7-8.2. This will avoid occurrence of alkalinity problems which will lead to decrease the soil permeability. It will also prevent or decrease the solubility of heavy metals and subsequently avoid their risk. The use of O.M is important to increase the soil fertility which is negatively affected due to the continuous cultivation. The electrical conductivity (EC) values are coinciding with the value of the non-saline soils which are ranged between 0-2 ds/m except for one location.

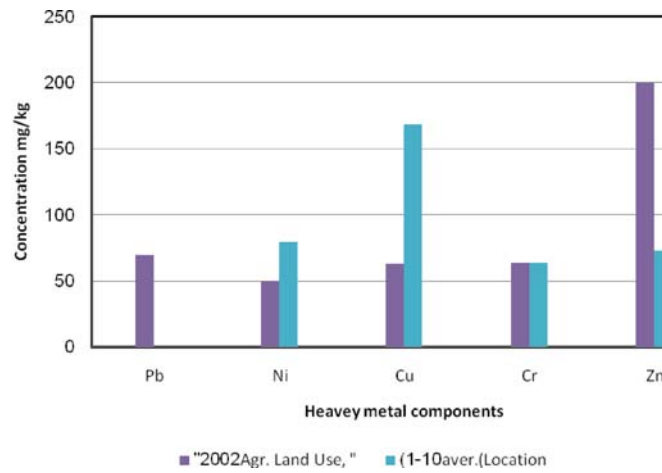
Fig. 4: Comparison of heavy metal content in bed material in Damietta branch to Canadian Agr. Land Use standard, 2002

Table 1 indicates the content of heavy metal in the collected samples. The average of the samples is compared to permissible values of agriculture land use, 2002 (see Figure 4). The figure indicates that the samples are suffering from heavy metal contamination however; the analysis indicates total content of heavy metal which includes soluble and precipitated forms. As the PH values of the soil are neutral to alkaline, which indicate that all the heavy metals are in insoluble forms. The problems of those metals may be appeared in case of decreasing PH value to the acidity range. As a factor of safety those soils can be cultivated by wood trees, palm dates, fruits without any environmental impact. Vegetables eaten fresh may not be cultivated in such soils.
