## **Upgrading and Reconstruction of a Collapsed Man-Made Lake Embankment Founded on Salty Soil**

**A. A. Abdel-Motaleb, A. A. El-Ashaal and S. Elkholy**

*Construction Res. Institute, National Water Res. Center, Egypt*

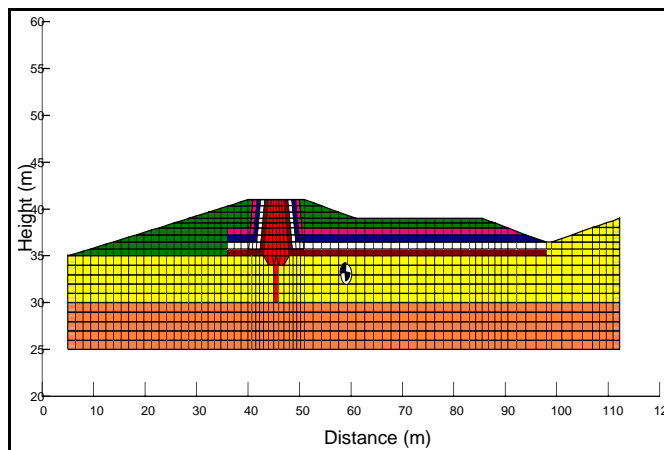
Figure 3. Finite element mesh of the embankment suggested cross section.

finite element method was utilized and Figure 3 shows the finite element mesh. The study included slope stability analysis, seepage analysis, and stress-strain analysis.
